# “Cosmics” Data December 2005

G.Gaycken

Calice ECAL Meeting, 6 March 2006

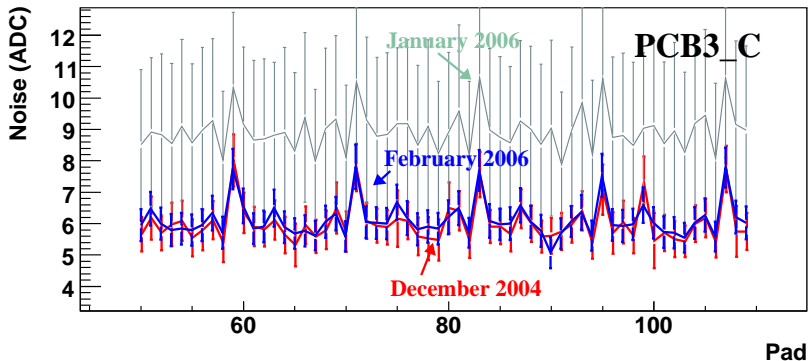
# Noise – Cosmics February 2006

Noise of old, previous and new cosmics runs.  
(December 2004, January 2006 and February 2006)
